HYDROLOGIC SERVICE AREA (HSA)

San Angelo, TX

MONTHLY REPORT OF HYDROLOGIC CONDITIONS

May

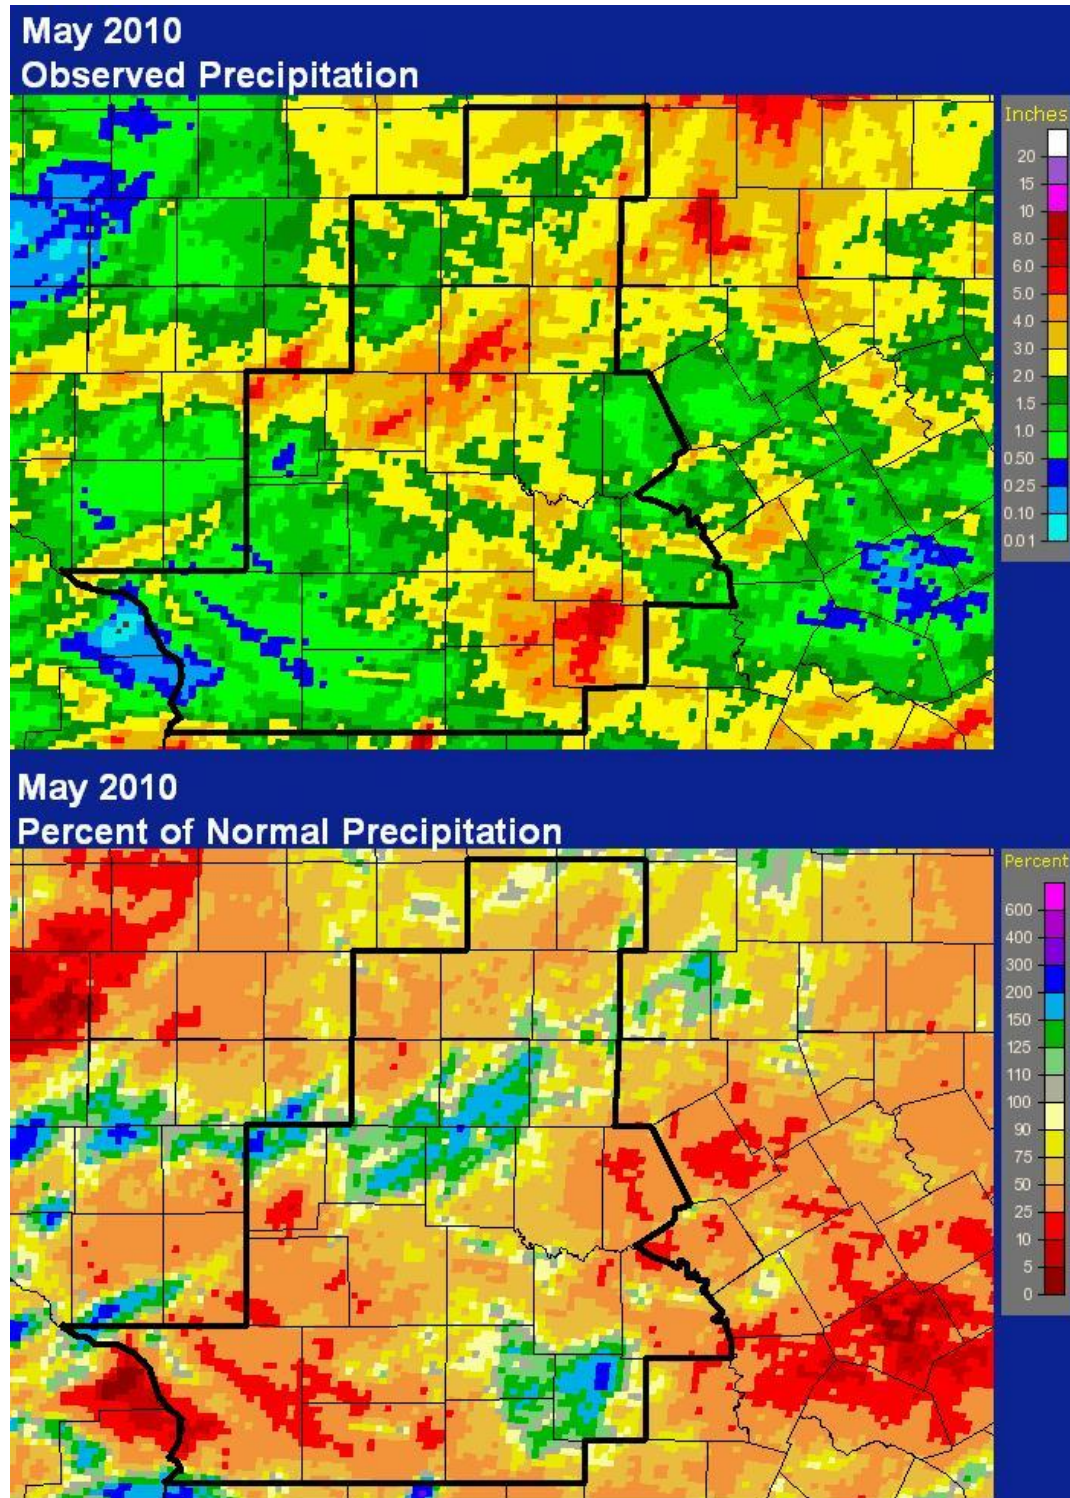
The total monthly precipitation estimate and percent of normal precipitation for May across the San Angelo HSA is depicted below.
